Colorado Division of Reclamation, Mining & Safety Project Summary

London Butte Mine Reclamation Project 2014, Park County, Colorado

London Butte Mine Reclamation Project

Work Description- Phase II

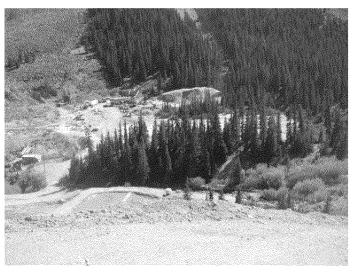
Top: London Butte Mine before and after reclamation. Bottom: Trestle at London Butte Mine left for historical significance.

In 2013, Phase I London area mine reclamation project involved reclaiming three tailings piles associated with the London Mine. Phase II of the project focused on the London Butte, and included consolidation of tailings, placement of dolomite cover, capping with clean fill, and revegetation, as well as building demolition and trash removal

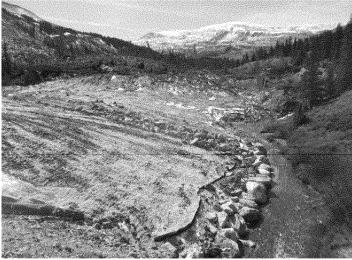
Left: London Butte Tailings material eroding into South Mosquito Creek, and further accelerated by the 2011 landslide. Photo dated 2012 prior to reclamation.

Below: 2014 London Butte Tailings removed, geogrid placed over soft subgrade and covered with dolomite, clean backfill and composted biosolids. Banks of South Mosquito Creek were reconstructed with riprap and the entire area seeded.
